Manhole Inspection Summary

Manhole # S15EE1002MH

Insp Date: **3/5/07 10:37 AM**

Location Address: **2448 SHIRLEY AVE**

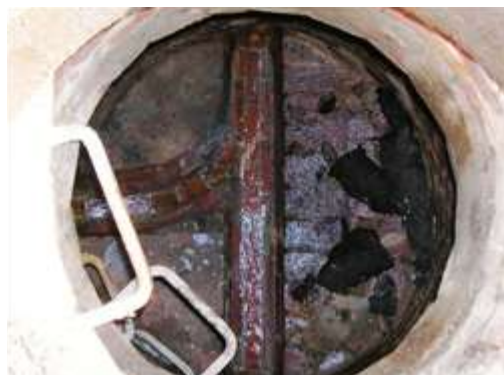
Top View

Evidence of surcharge - Bench debris.
Corroded steps.

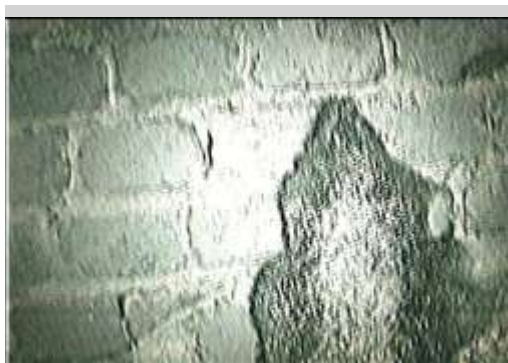
Defect

Barrel infiltration.

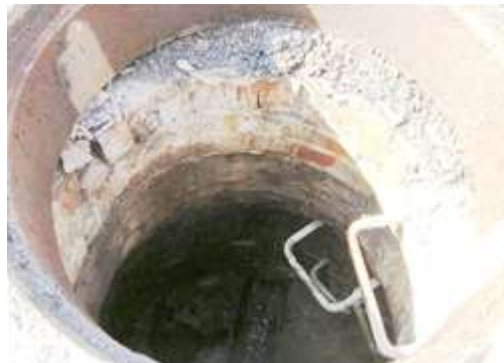
Defect

Frame leaks. Frame offset. Adjustment
deterioration, loose brick and infiltration.
Corbel and Barrel infiltration - other side.

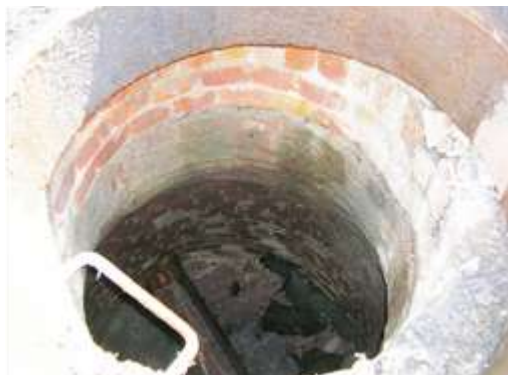
Defect

Frame leaks. Frame offset. Adjustment
deterioration, loose brick and infiltration.
Corbel and Barrel infiltration.

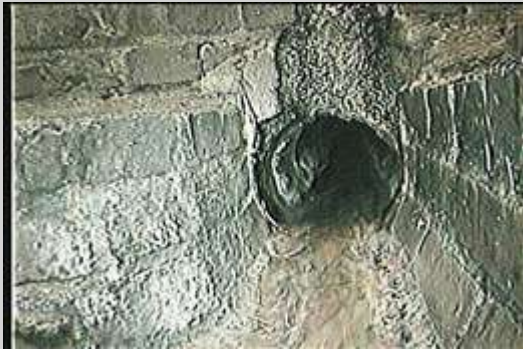
8 in. Circular Gravity Sewer Pipe Out @ 12 O'Clock

Barrel deterioration and infiltration.

Deposits: ☐ None ☐ Mud ☐ Sludge ☐ Debris ☒ **Grease**

Silt Depth: **0** (in.) Deposits Extent: **Light**

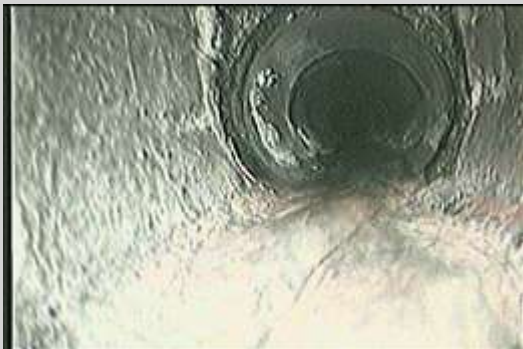
8 in. Circular Gravity Sewer Pipe In @ 6 O'Clock

Deposits: ☐ None ☐ Mud ☐ Sludge ☐ Debris ☒ **Grease**

Infiltration: **Evidence** Pipe Seal Cond: **Unknown**

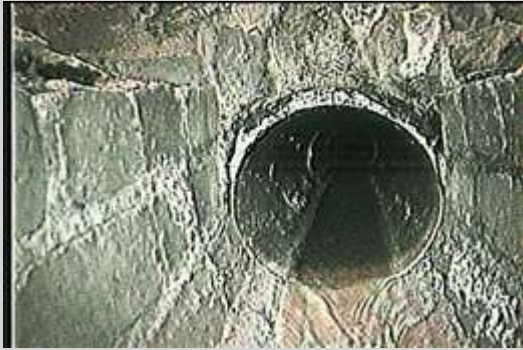
Pipe In @ 9 O'Clock

Deposits: ☐ None ☐ Mud ☐ Sludge ☐ Debris ☒ **Grease**

Infiltration: **Evidence**

Pipe Seal Cond: **Cracked**
